**City of Clarence-Rockland**

**Celine Street Rehabilitation**

**ADDENDUM No. 1 TO CONTRACT**

**RE: SLOPE STABILITY STUDY  
LOTS 49 TO 53  
PART LOT 6, CONCESSION 6,  
TOWNSHIP OF CLARENCE, ONTARIO**

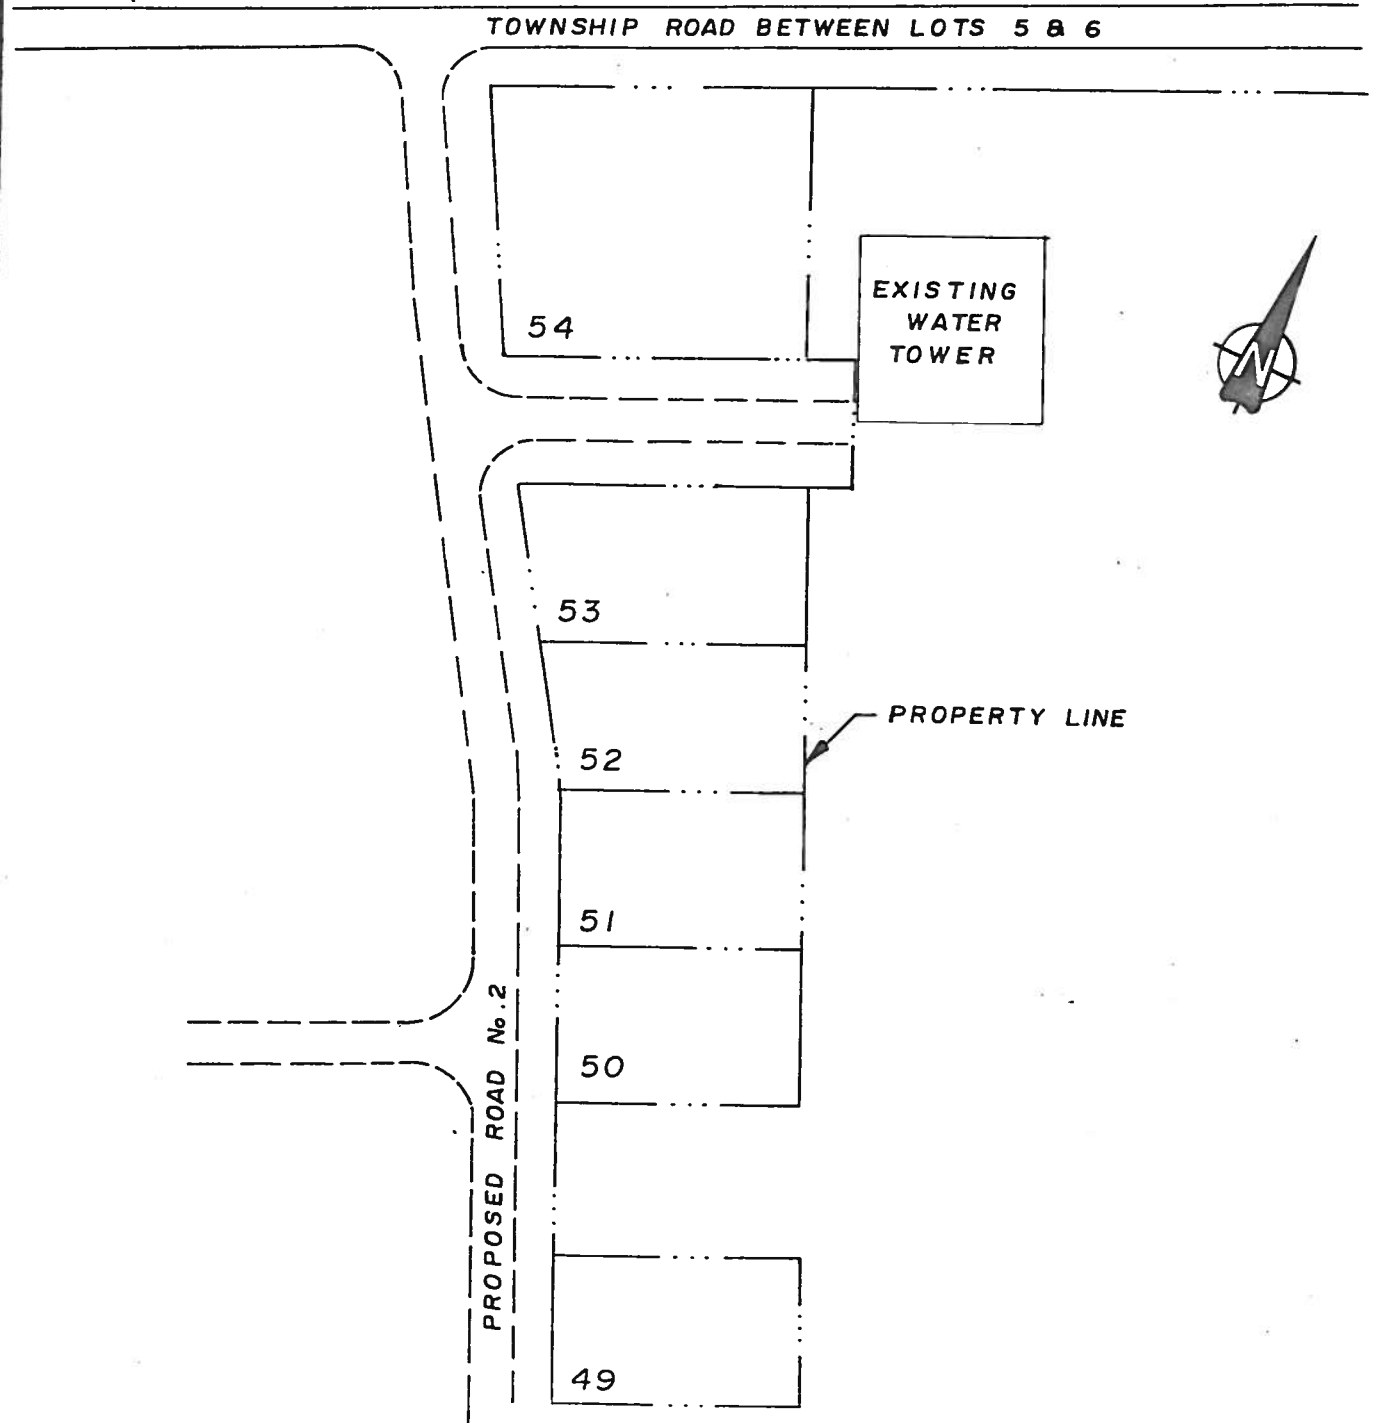
FIGURE 2

The crest of the slopes in this part of the site ranges from about 9 to in excess of 25 metres east of the east property line. The natural slopes in this area were found to be about 14 metres high and to have slope angles of about 2.5 horizontal to 1 vertical. Fill materials, consisting of sand and silty clay have been placed along the lower portion of the slopes adjacent to lot 52. The surface of the fill has been graded to about 4.5 horizontal to 1 vertical.

The stability analyses indicated that the slopes adjacent to lots 52 and 53 have a factor of safety ranging from about 1.2, which is marginal, to 1.5, which is acceptable, in their present condition. The east property line for these lots will, however, be outside the zone of influence of slope movement in all cases (i.e. the factor of safety at the lot line is consistently 1.5 or greater). As such, the proposed development of lots 52 and 53 is considered to be geotechnically acceptable provided that the existing grade is maintained in the area from the east property line to the crest of the slopes.

Lots 49 to 51 are located at least partially on the slopes. From examination of the contours shown on the draft plan of subdivision and observations during the site visit, it is known that the natural slopes in this area are about 10 metres high and have a slope angle of about 3.5 to 4 horizontal to 1 vertical. Some fill, consisting of sand and silty clay has been placed on these slopes and is presently standing at an inclination of about 4 to 5 horizontal to 1 vertical.

It is considered that the proposed development in lots 49 to 51 will be geotechnically acceptable and that the slopes will have an adequate factor of safety provided that the following constraints are followed:

- 1) The foundations for the houses should be placed on native sand or silty clay or on well compacted granular fill placed over the native soil.
- 2) Fill materials placed on the slopes should be spread in layers about 0.3 metres thick and compacted using several passes of a tractor dozer.

- 3) The fill materials should be shaped to a slope no steeper than 4 horizontal to 1 vertical.
- 4) The surface of the filled slopes should be mulched and the ground cover re-established as soon as possible after final grading to resist surface erosion. This could be accomplished by seeding and mulching as well as planting shrubs. Vegetation having deep, wide spread root systems is best suited for planting on the slopes.

- 5) The septic tile beds, which are to be placed behind the houses, are constructed carefully so as not to adversely affect the stability of the slopes. In this respect, the effluent should not be allowed to outlet directly onto the slopes.
